**REPORT ON THE DAMAGES ON BUILDINGS
FOLLOWING THE SEISMIC EVENT OF 6TH OF
APRIL 2009 TIME 1.32 (UTC) – L'AQUILA M=5.8**

Gerardo Mario Verderame, Iunio Iervolino, Paolo Ricci
verderam@unina.it; iunio.iervolino@unina.it; paolo.ricci@unina.it
Department of Structural Engineering, University of Naples "Federico II"

A wide photographic documentation on the principal collapses and the different failure mechanisms, both on reinforced concrete and masonry buildings, has been produced based on different surveys, carried out from Monday 7th of April 2009 up to Friday 10th of April 2009.

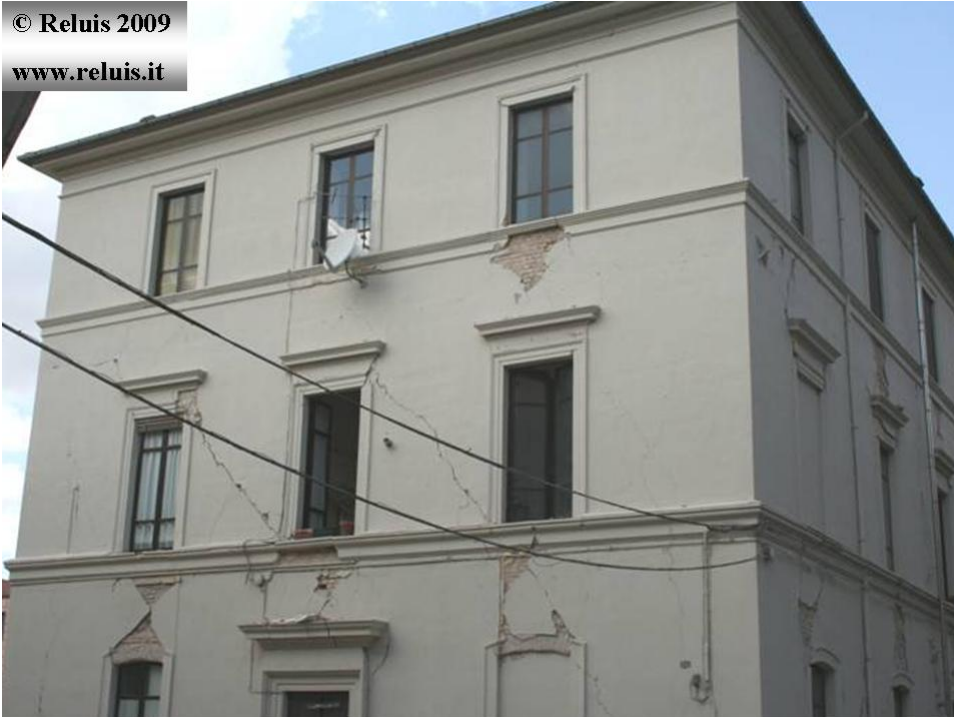
Masonry building located in Via XX Settembre – L’Aquila

Evidence of diagonal cracks in masonry walls at the second level of the building.

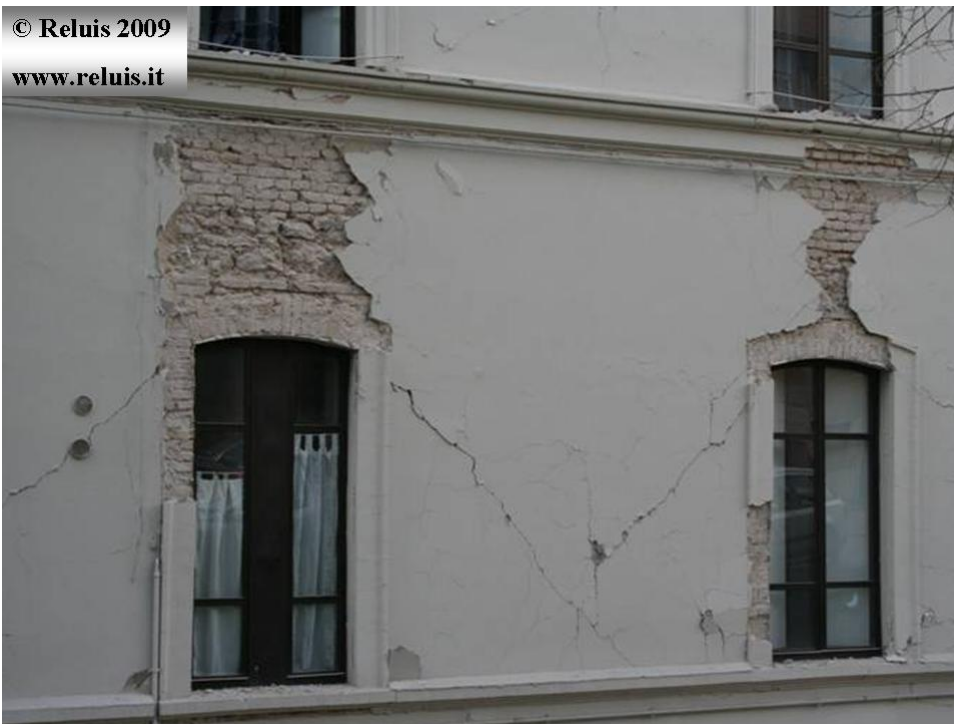
Masonry building located in Via XX Settembre – L’Aquila

Diagonal cracks involving spandrel beams and masonry walls at the first level.

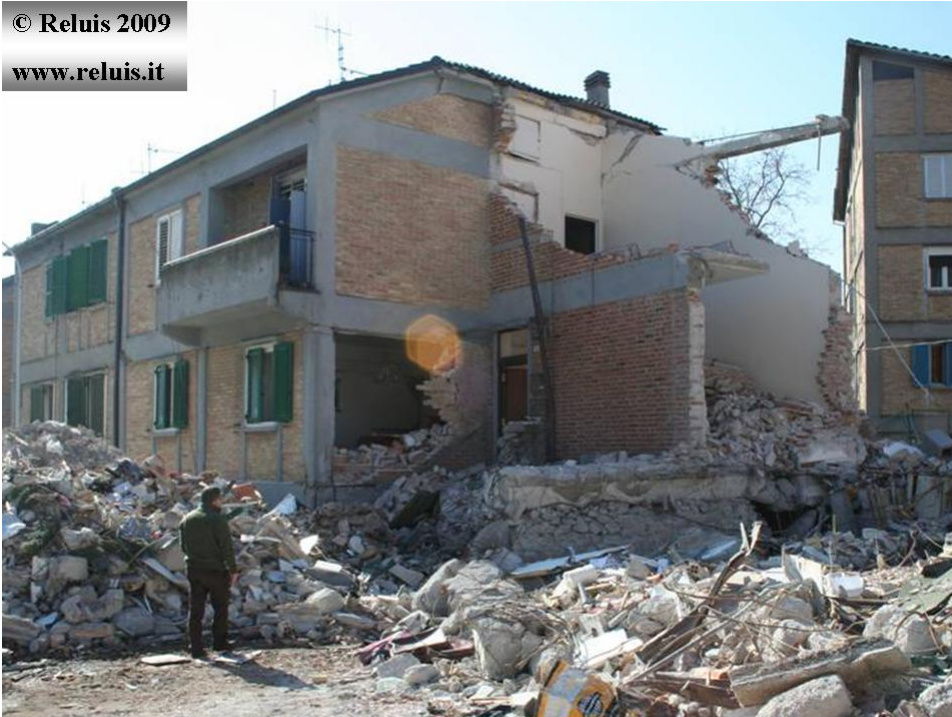
Collapse of a reinforced concrete (R.C.) building

Construction realized in 60's in adhesion with a pre-existing building. Infill panels are made up of solid bricks, R.C. elements are reinforced with plain bars.

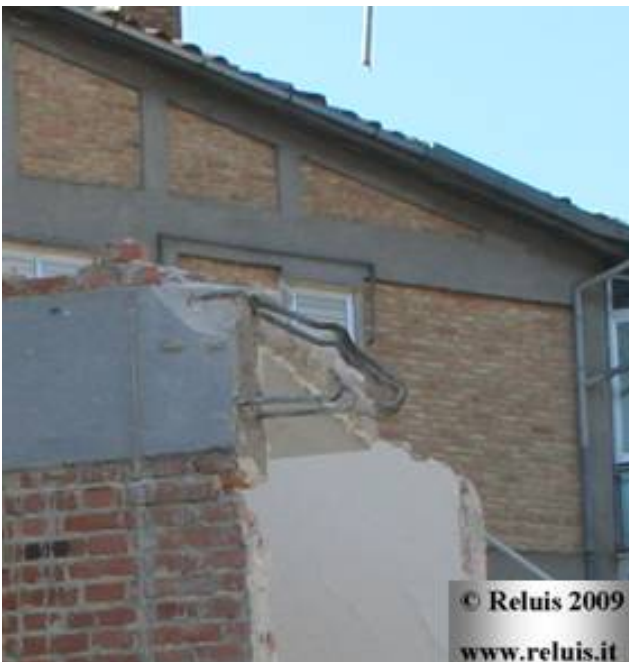
Collapse of a reinforced concrete building

Detail of longitudinal plain reinforcement of the beam. The hook anchorages both of inferior and superior reinforcement are clearly shown.

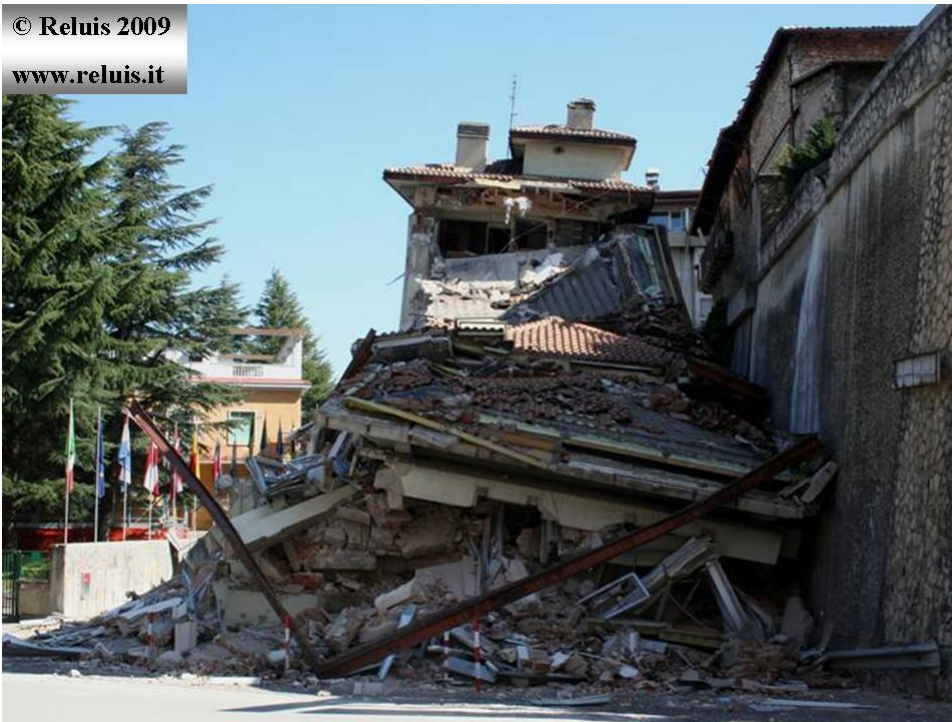
Hotel Duca degli Abruzzi – L’Aquila

Collapsed wing of the building. The remaining part, severely damaged, is strongly inclined.

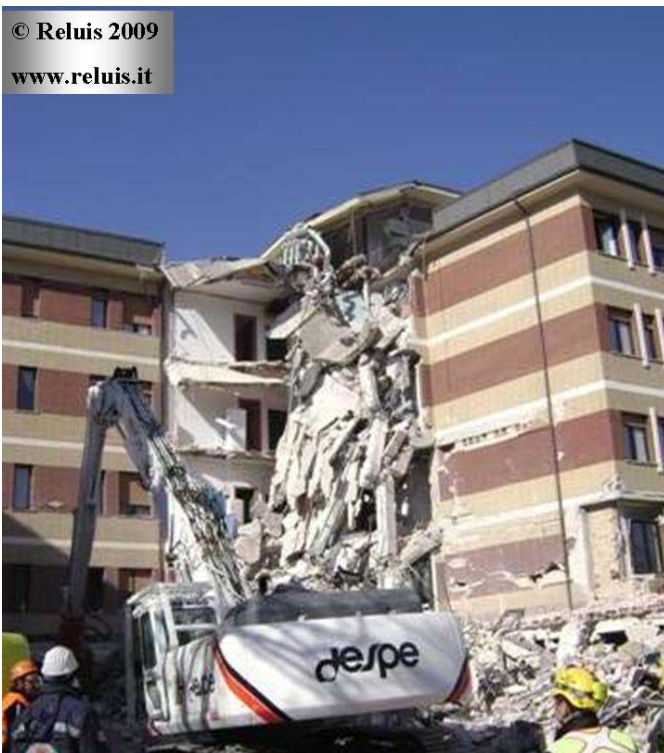
Casa dello Studente – L’Aquila

Image of the collapsed portion of the building. The failure mechanism involved all of the stories; beams show a high plastic rotation.

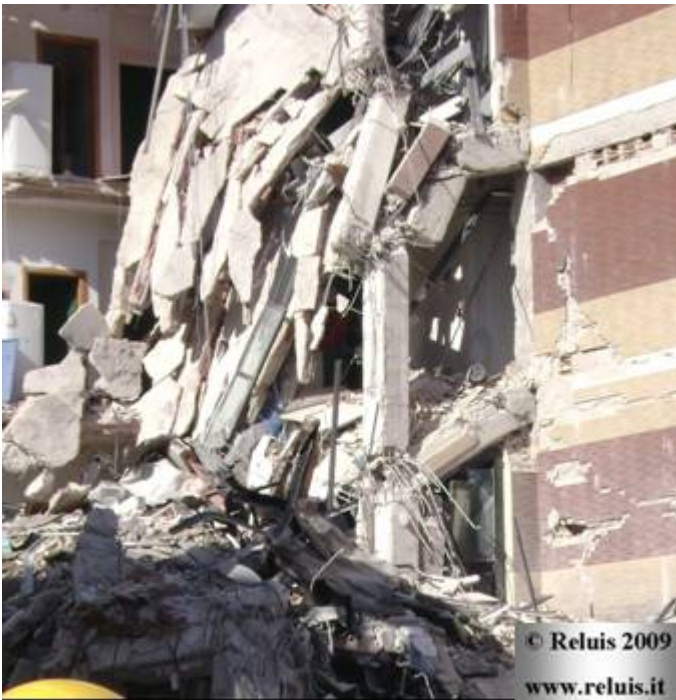
Casa dello Studente – L’Aquila

Detail of the plastic rotation of floor slab (beams).

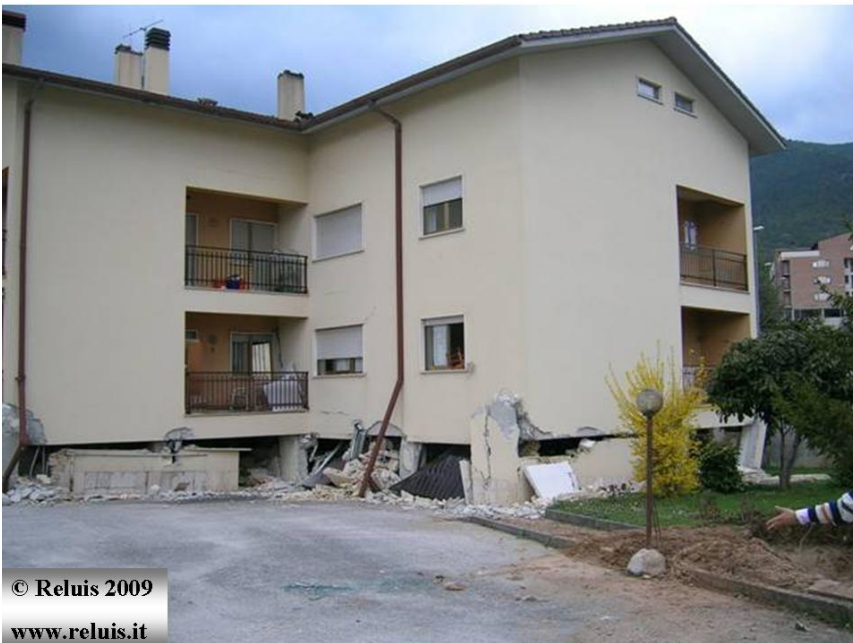
Soft storey mechanism on a three stories R.C. building – Pettino (AQ)

First storey is characterized by wide openings (entrance and garages) unlike the remaining ones; the displacement demand has been concentrated at the ground level.

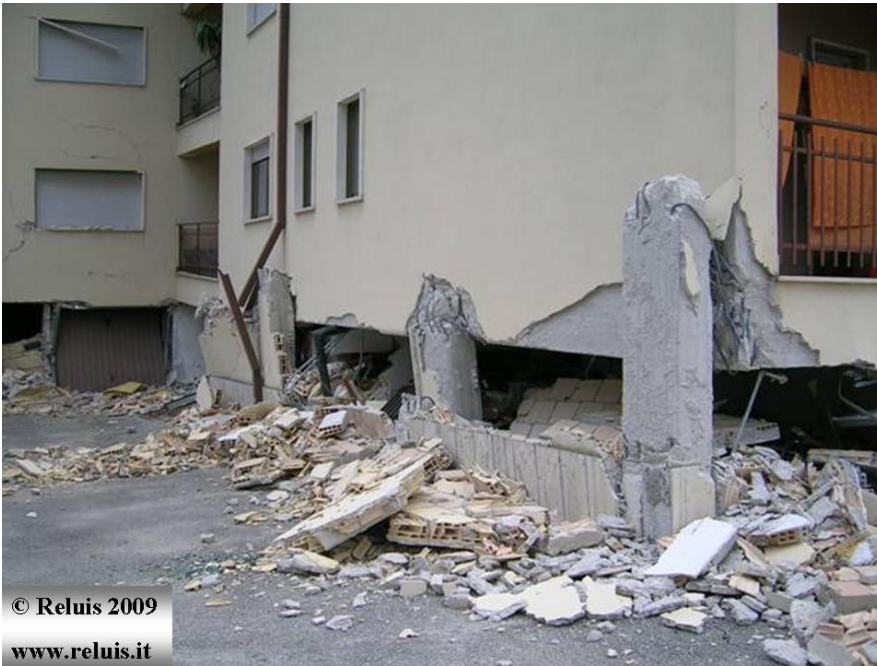
Soft storey mechanism on a three stories R.C. building – Pettino (AQ)

First level columns damage. First and third columns seem to be completely apart from the structure, second one has kept its original position unless a foundation settlement.

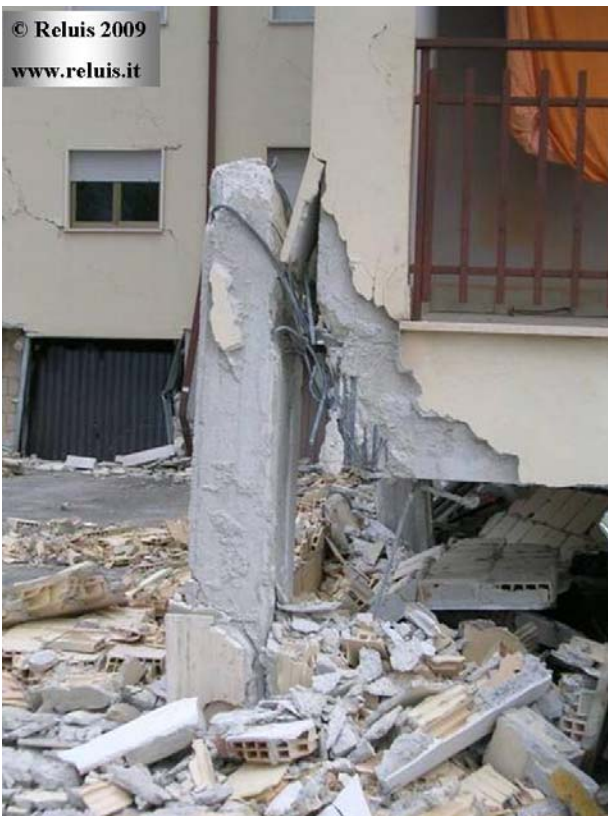
Soft storey mechanism on a three stories R.C. building – Pettino (AQ)

Detail of the corner column. It is worth to note stirrups absence in the beam-column joint.

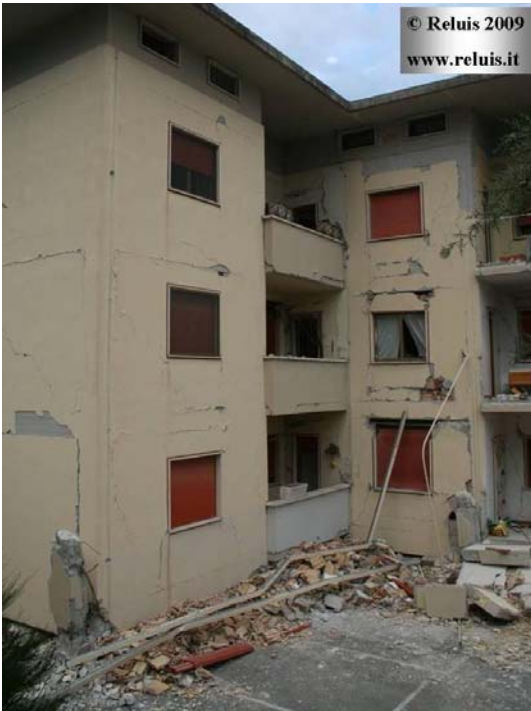
Soft storey mechanism on a four stories R.C. building – Pettino (AQ)

As well as the previous case the first storey shows large openings: displacement demand is concentrated at the ground level.

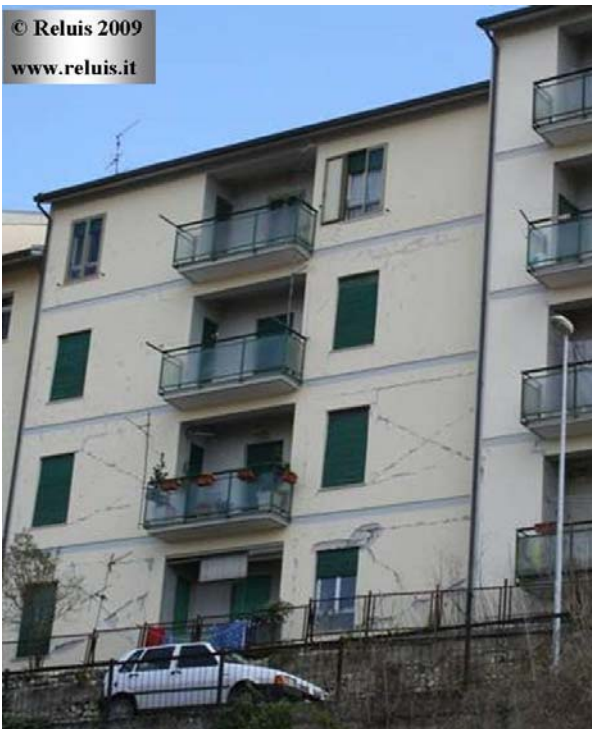
Infills damage: four stories R.C. building

Evidence of typical diagonal cracks at the first two levels.

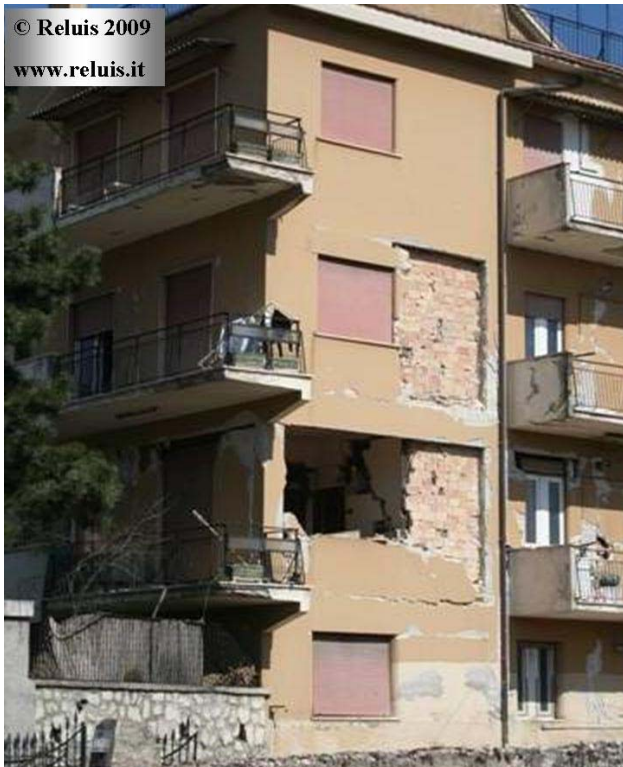
Infills damage: four stories R.C. building
External infills ejecting at the second and third levels.
Photo by P. Ricci and G.M. Verderame

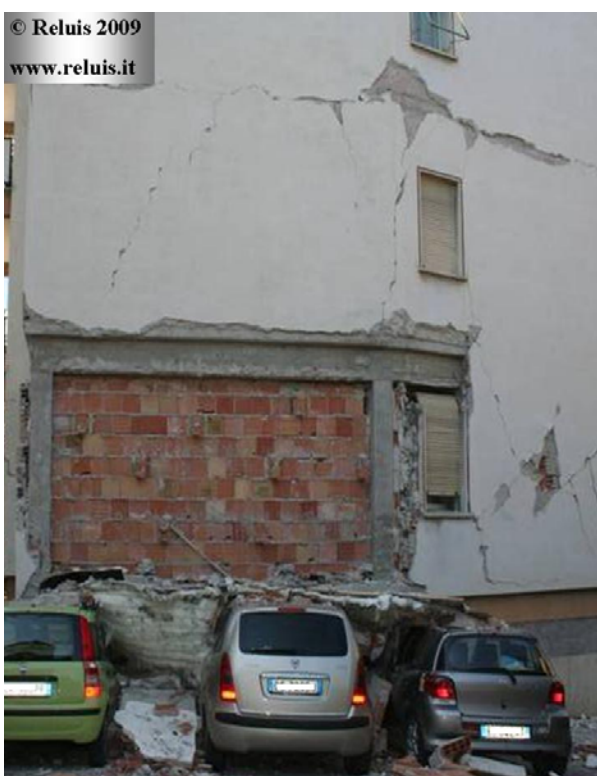
Infills damage
Double clay block infill. External infill ejecting, ruined on cars beneath.
Photo by P. Ricci and G.M. Verderame

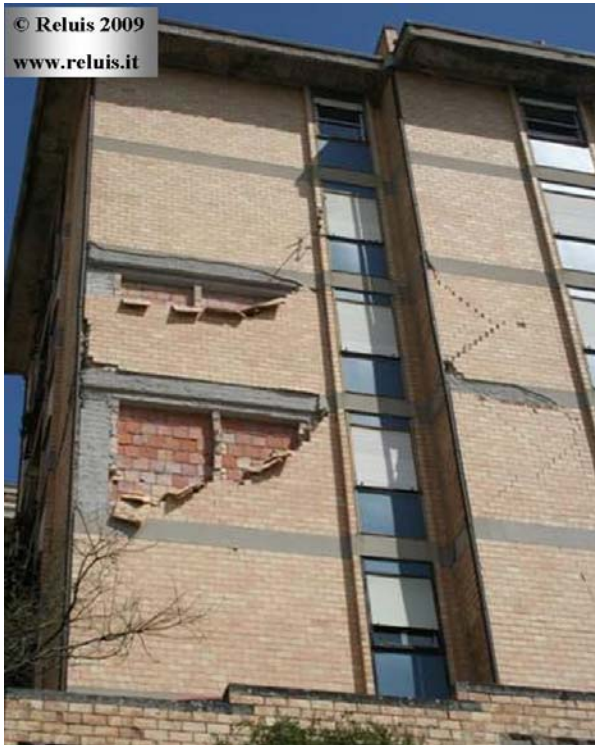
Infills damage

Internal infill is made up of clay blocks, external one of solid bricks.

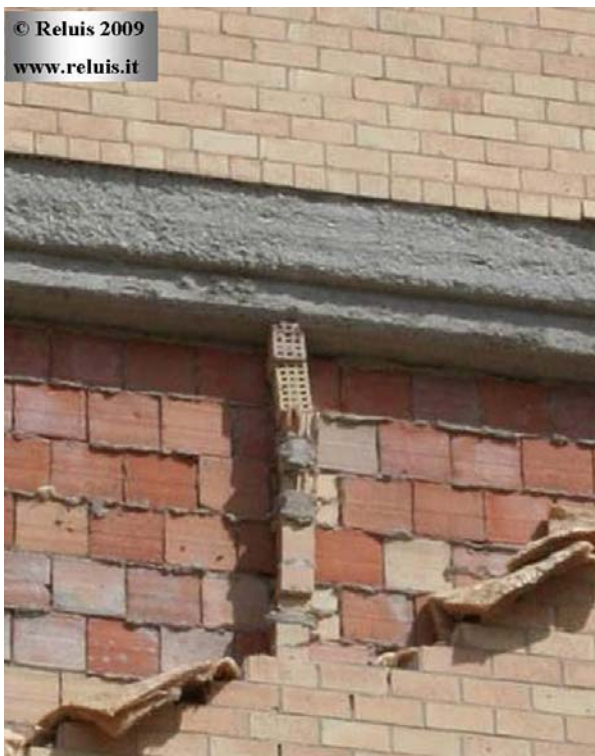
Infills damage

Clay blocks connection between internal infill and external one. Upper bound of the external infill is encased in the beam through a tooth jutting out of the R.C. beam.

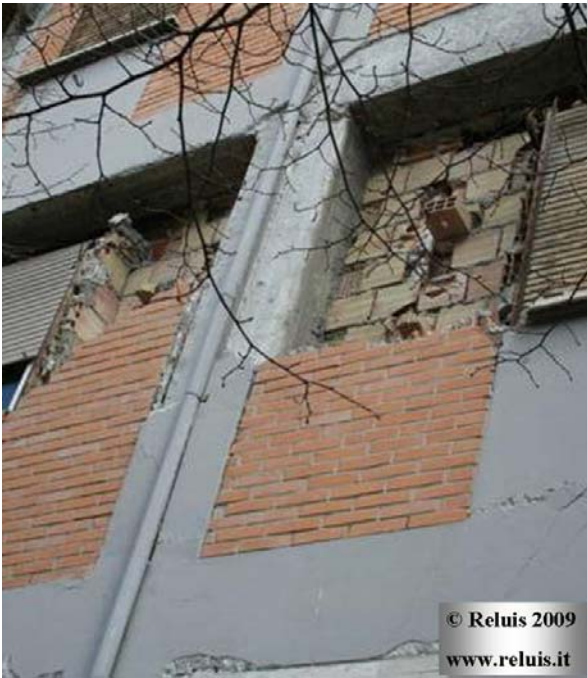
Infills damage close to windows openings

Connection between the two infills is made up of single clay blocks or solid bricks placed 50-60 cm from one another.
Photo by P. Ricci and G.M. Verderame

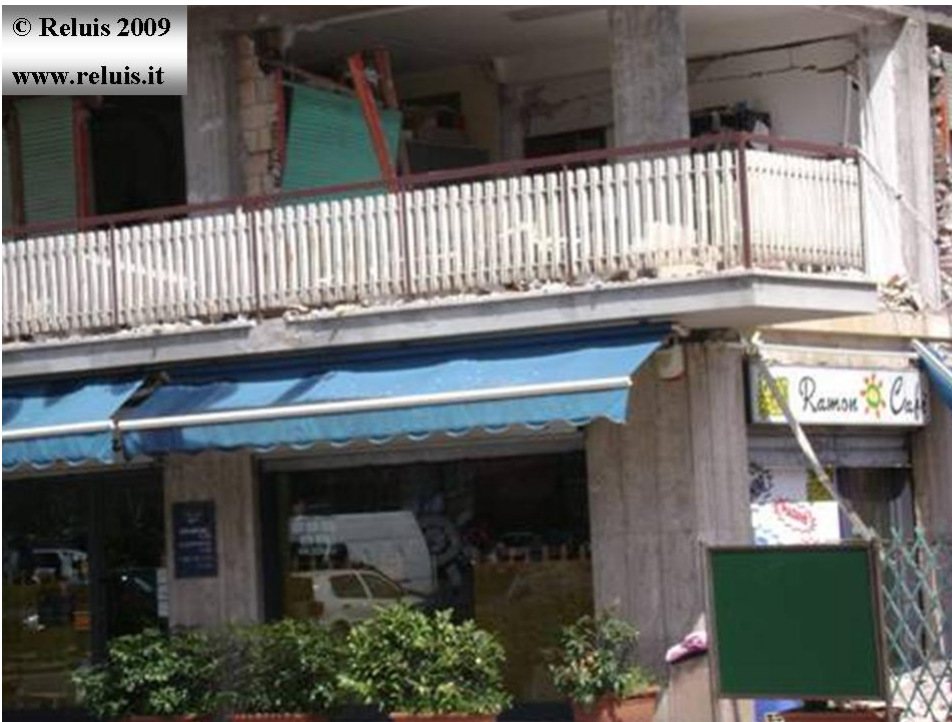
Reinforced concrete building placed in Via XX Settembre – L'Aquila

Building is characterized by pronounced plan irregularity. It is worth to underline the complete infill ejecting at the ground floor and the internal infills damaging. Marble coverings and shop glazes at the ground level do not show any damage.

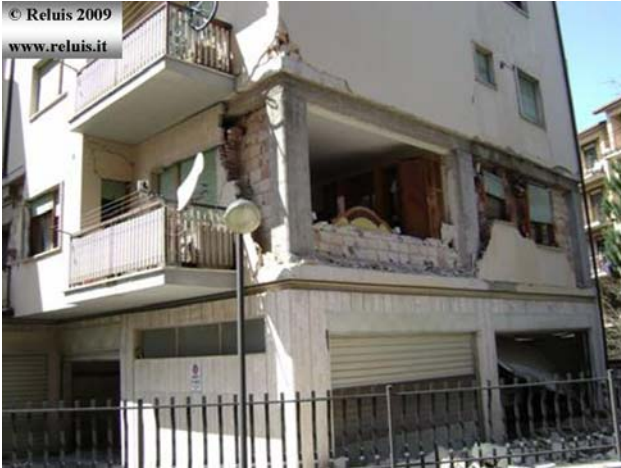
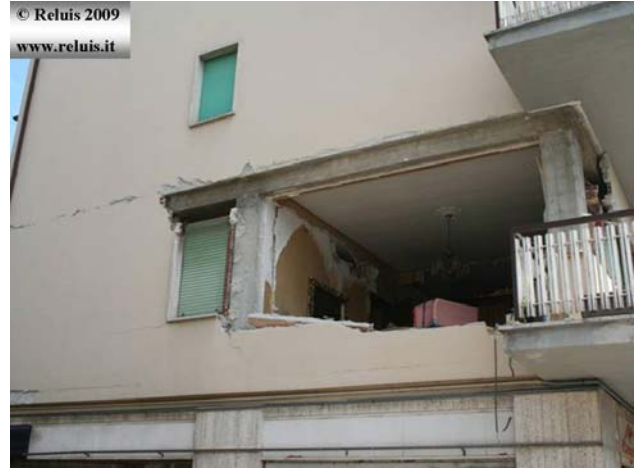
Reinforced concrete building placed in Via XX Settembre – L'Aquila
Total and partial ejecting of corner infills at first level.
Photo by I. Iervolino

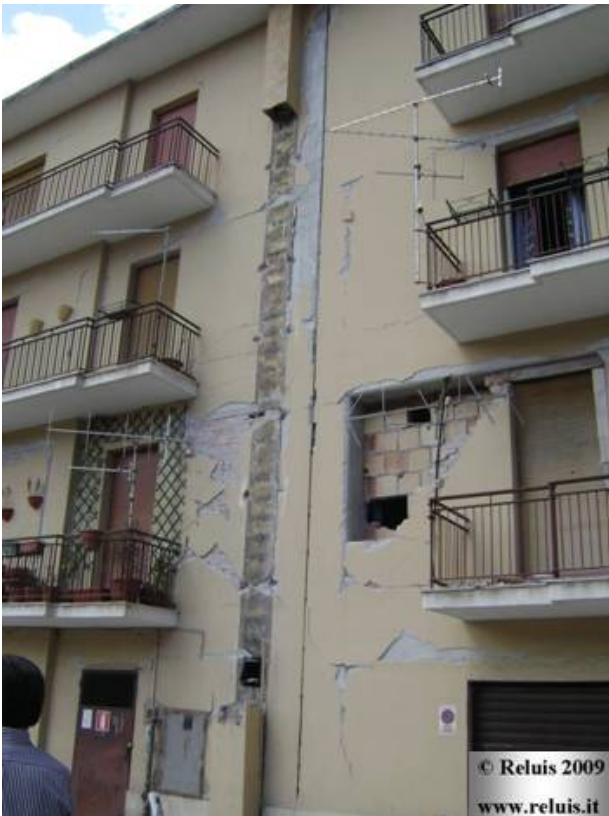
Infills damage
Partial ejecting of external infill, made up of solid bricks. The separation joint, large about 2 cm, and collapse of clay blocks flue are clearly shown.
Photo by I. Iervolino

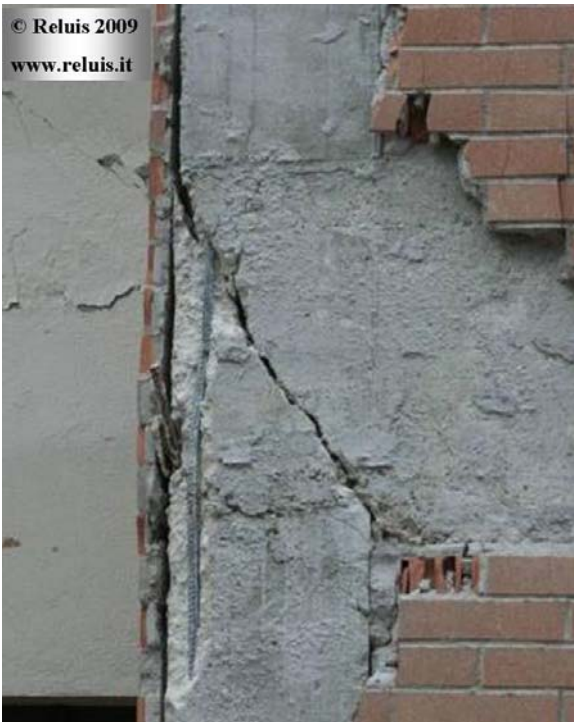
External joint damage

Diagonal cracking highlights a shear failure of the external joint. Buckling of longitudinal bar highlights total absence of stirrups in the joint and along the first 20-30 cm of upper end of column.

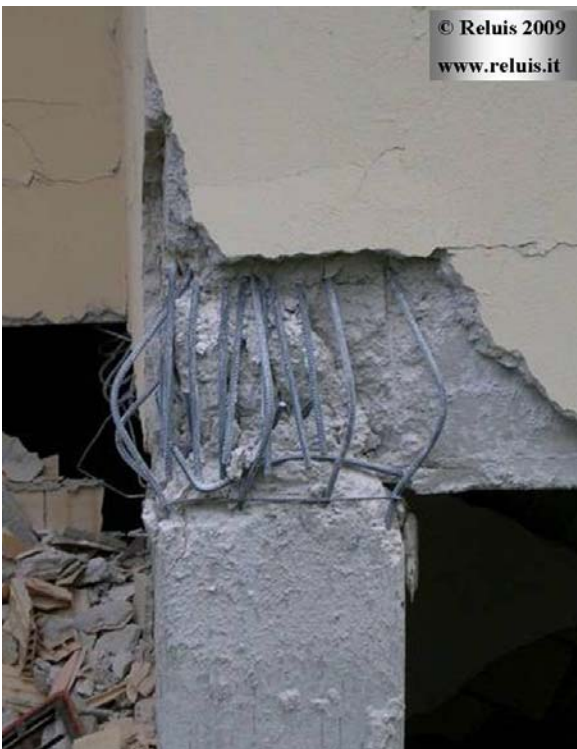
External joint damage

Stirrups absence in joint involves buckling of longitudinal bars in column; concrete cover spalling is due to the anchorage of longitudinal bars in orthogonal beam.

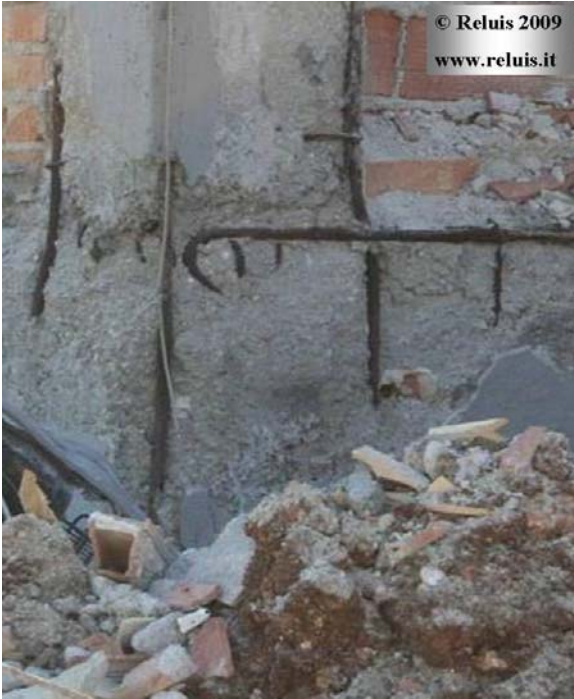
External joint damage

Reinforcing bars are plain, concrete shows scarce quality. Hook anchorage of beam longitudinal bars, absence of stirrups in joint and stirrup spacing in columns are evident.

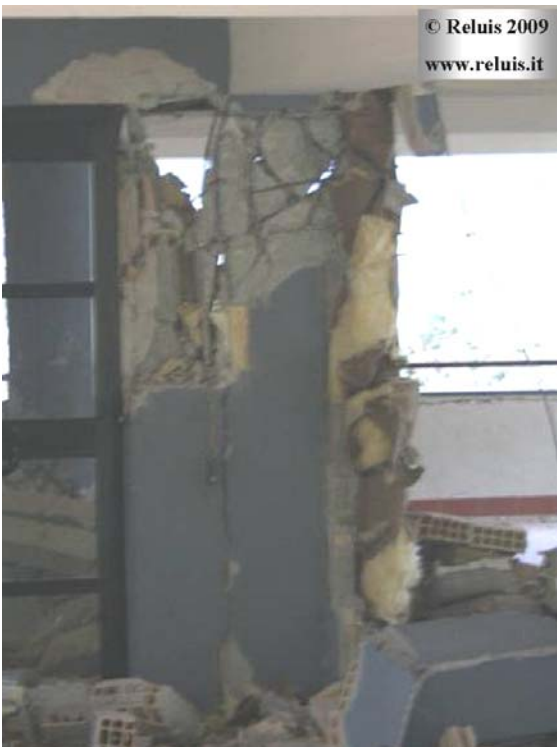
Column damage

Upper end failure of column highlights scarce concrete quality and poor transversal reinforcement.

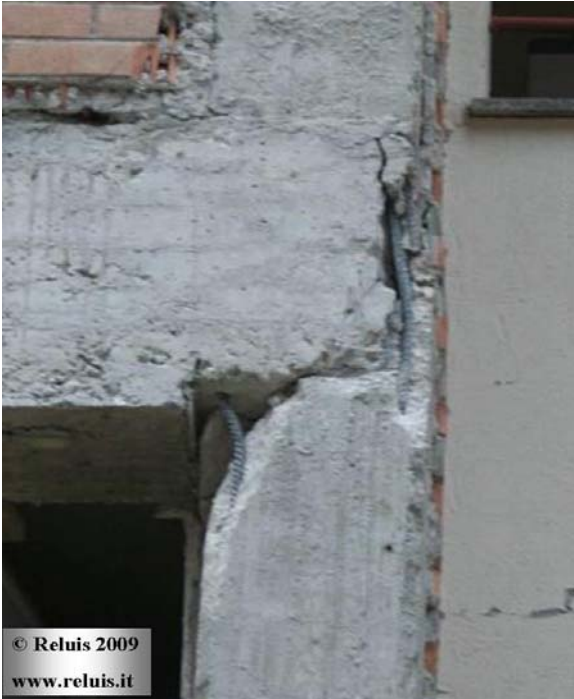
Column damage

Upper end failure of the column clearly underlines the casting separation between beam and column. Stirrups absence along first 20-30 cm of column is clearly showed again.

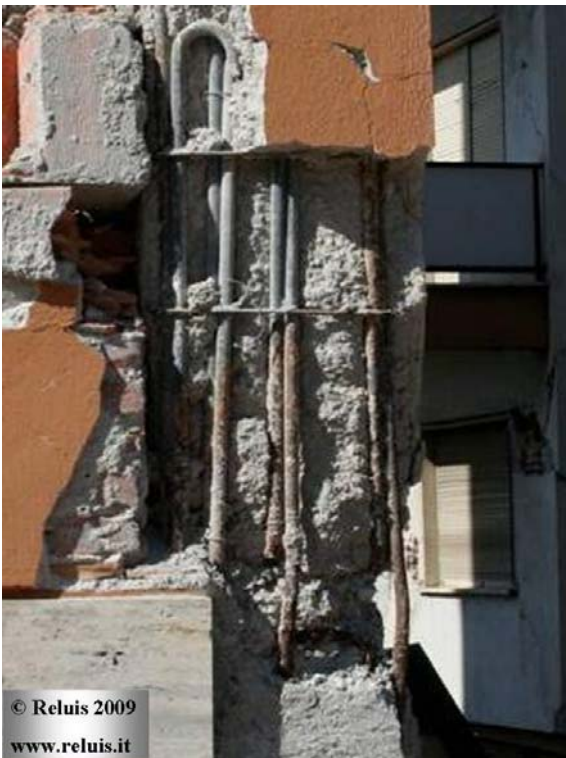
Column damage

Overlapping detail of longitudinal reinforcement in the column. Plain reinforcing bars are anchored with end hooks. Stirrups absence along first 30-40 cm of column is showed.

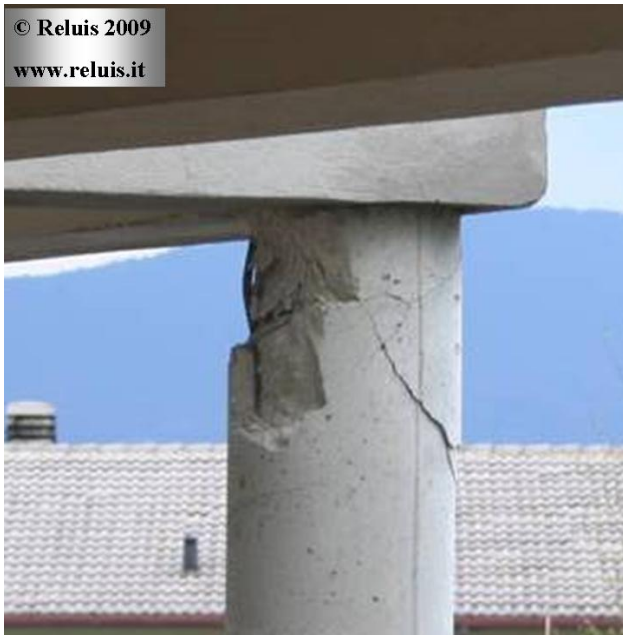
Column damage

Shear failure of upper column end. Longitudinal bars are buckled and transversal reinforcement is poor.

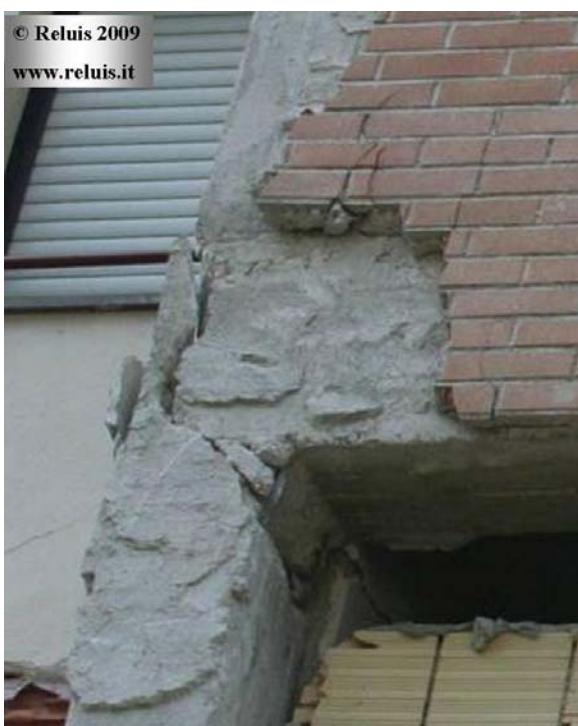
Column damage

Diagonal failure of upper column end involving part of beam-column joint. Two longitudinal bars in column are buckled and stirrups are absent along first 20 cm of the column.

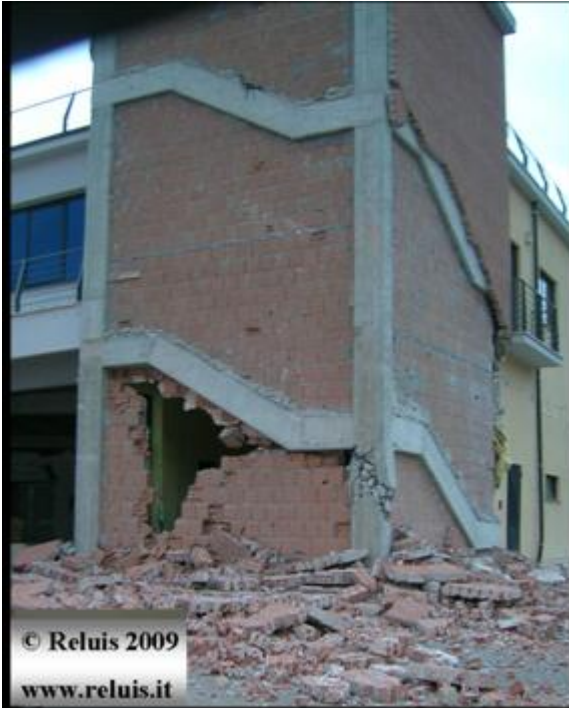
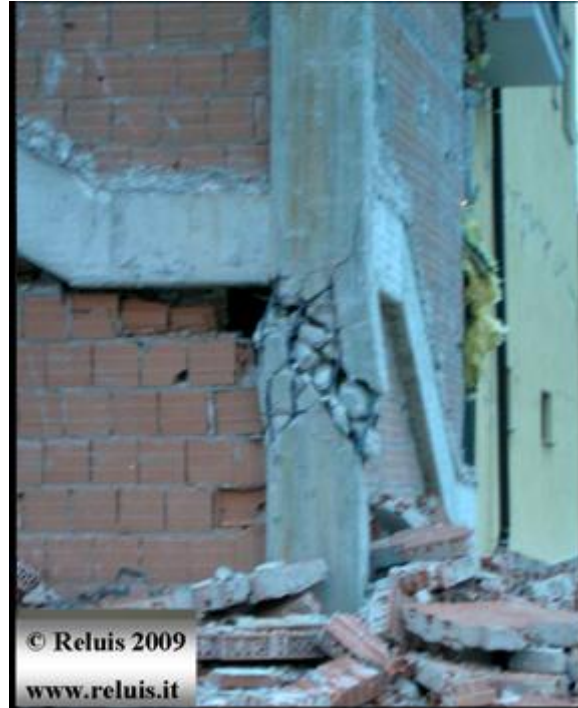
Stairs damage
Shear failure of a short column in the staircase.
Photo by G. De Carlo and G.M. Verderame

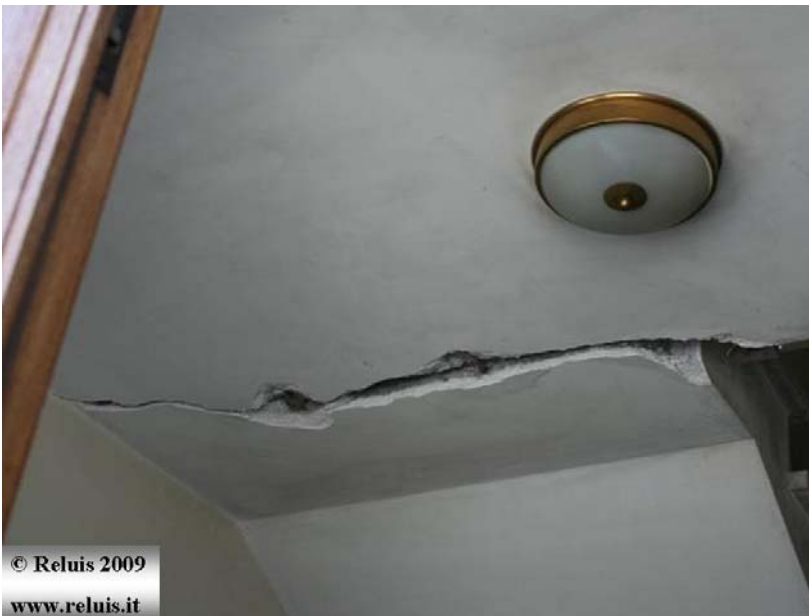
Stairs damage
Wide crack between stair slab and last step.
Photo by P. Ricci and G.M. Verderame

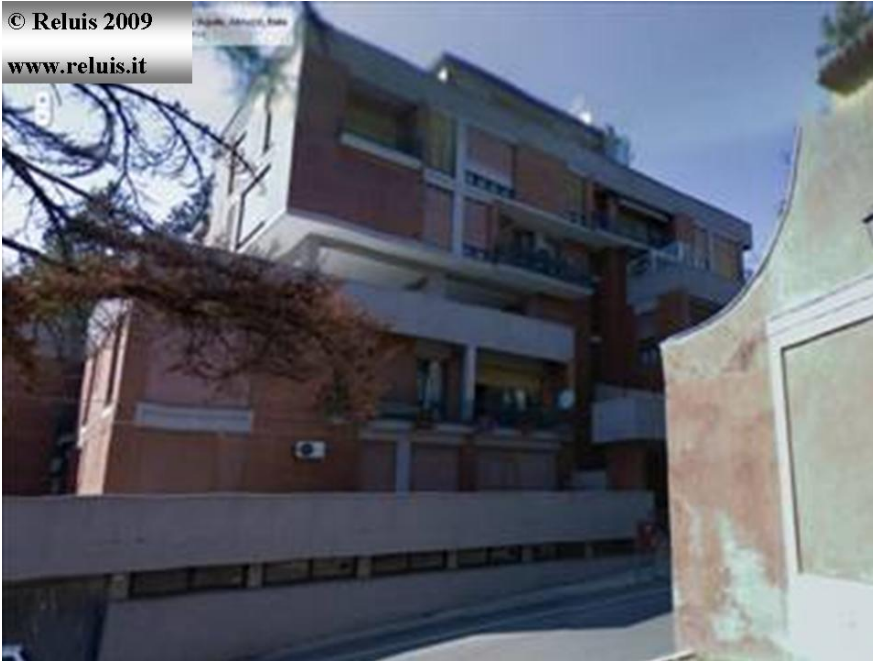
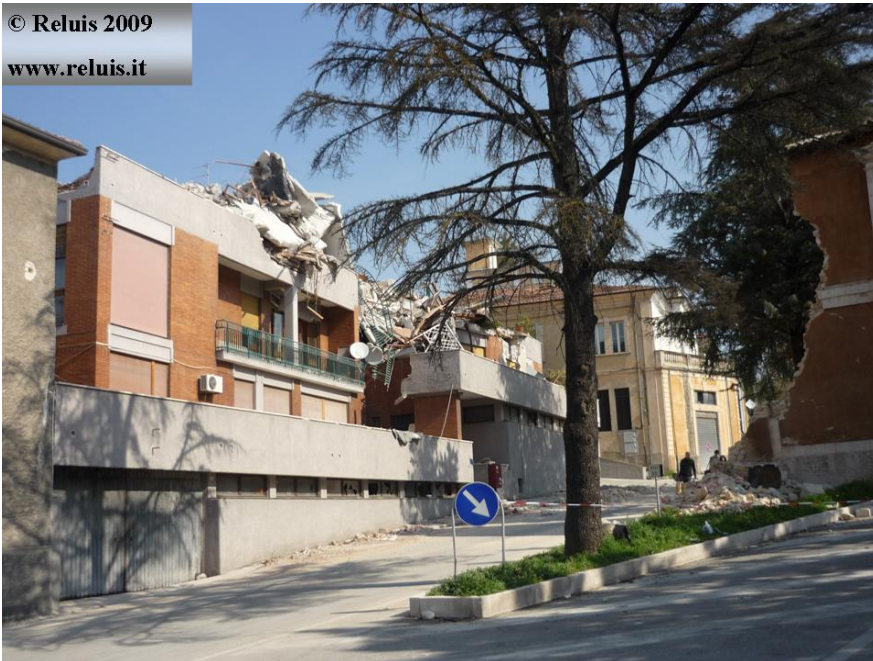
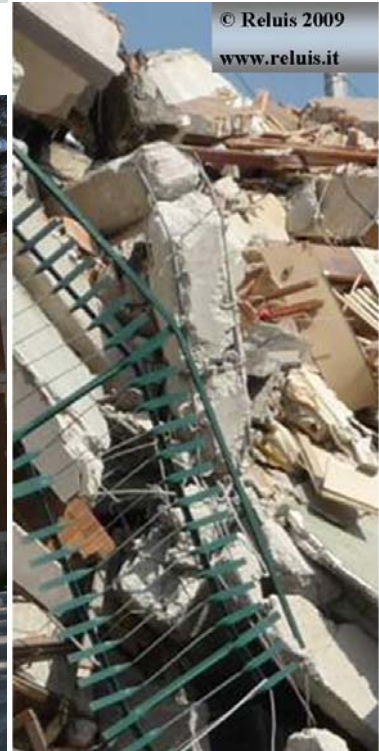
Residential building at Porta Napoli

Up and right (from Google StreetView): the building before the quake. Down: The soft floor between 2nd and 4th level has collapsed, due to the failure of the RC columns (pilotis), whose reinforcement, both rebars and stirrups, is clearly visible in the detail.
